Fatal 6 - Serious road traffic accident involving volumetric vehicle overturning

ALERT STATUS: Normal
DATE ISSUED: 24/07/2019 14:21:53
INCIDENT No: 01519

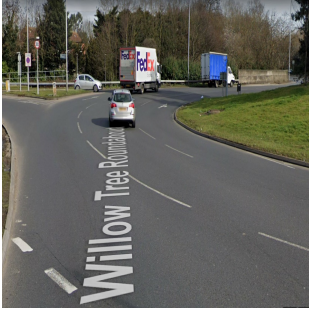
The driver slowed down as he approached a roundabout in the first lane, as he entered the roundabout, he accelerated to continue on the main road at the second exit. As the vehicle passed the 1st exit and continued to steer around the roundabout, the rear right wheels lifted. This action made the chassis flex and caused the metro flow tank at the rear of the vehicle to lean. This caused the load to shift which resulted in the vehicle toppling over. The vehicle fell onto the passenger side. No other vehicles were involved.

The image below shows the road where the accident occurred, the blue van marks the position where the vehicle overturned.

- Provide an Incident Notification
- Lessons Learned document will be produced within 14 days
- Ensure loads on volumetric vehicles are evenly distributed
- Ensure that the gross weight is recorded before exiting sites
- Request and review all footage and documentation
- Investigation into incident by SHEQ Manager in conjunction with Transport Supervisor
 - Interview driver
 - Request information from Police (CAD number recorded at scene)

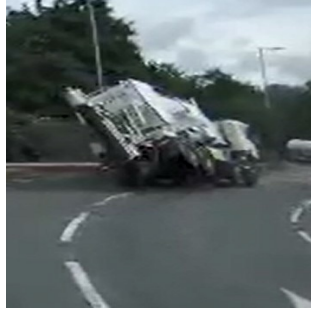
A camera captured an image prior to the truck toppling over.

Camera image of vehicle overturning
