BEST PRACTICE

| ACTIVITY: | Pedestrian and transport safety on-site | COMPANY: | Tarmac |
| SUB ACTIVITY: | No Sub Activity Available | COMPANY LOCATION: | Mountsorrel Quarry |

Solar powered lighting installation to reduce the risks of slips, trips and falls on pedestrian walkway

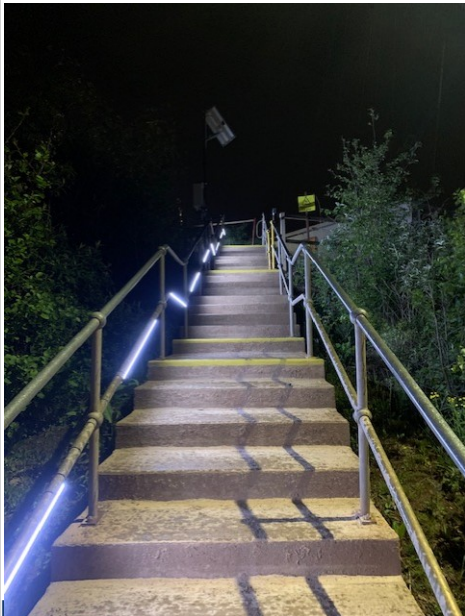
Image of stairs with new lighting

We chose a set of concrete steps leading to the primary crusher which were not illuminated at night to see what difference it would make and have submitted the before photos to demonstrate the difference. This was a well-used walkway for staff, contractors and site visitors which posed a hazard when working in the hours of darkness as the steps were not easily visible.
