BEST PRACTICE

LOCATION: Asphalt/Coating plant
ACTIVITY: Transport & Logistics / Delivery
SUB ACTIVITY: Delivering Asphalt & Hot Boxes
BEST PRACTICE No: BP2221
COUNTRY OF ORIGIN:

Device designed to hold open the chutes on the rear door of asphalt tipper lorries. - Topic 6

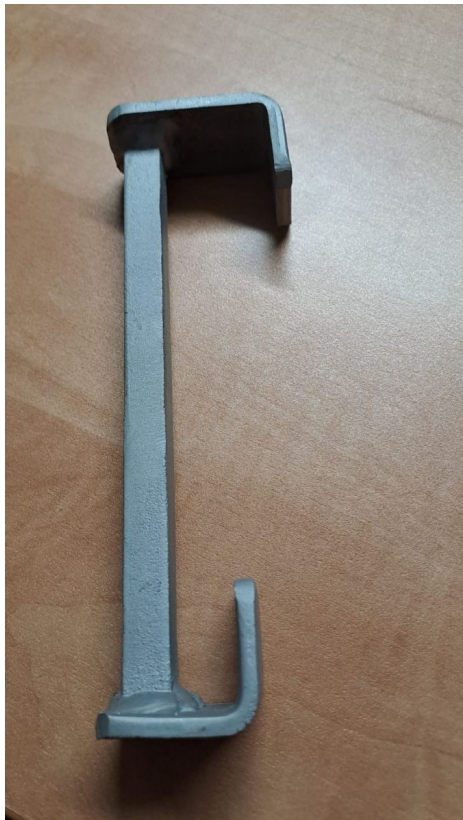
The images below show the device and the device being used.

The tail door on this style of tipper lorry is inset to the body rather than sitting external to it, so to close the tail door the contact surfaces need to be cleared. The driver has to either manually hold open or else insert a prop into the heavy tail door in order clear the door sill of hot material.

The issues associated with working around and clearing the tail door include - manual handling of the heavy tail door, contact with hot material (burns), nip/ trap injuries when removing props or closing the tail door and finally, additional time spent by the driver in a live site environment (close to road traffic, site traffic).

In 2023, a contract HGV driver received a hand injury which required stitches when the prop that he was using to hold the tail door open slipped and the tail door closed suddenly catching and injuring his hand.
