BEST PRACTICE

CCTV cameras reduce tipper overturns

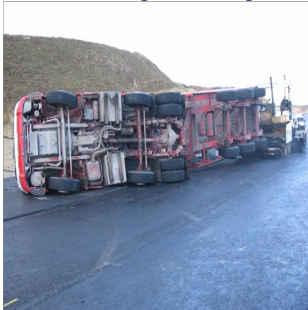
vehicle tipping

One of the difficulties associated with the transportation and tipping of heavy loads is the overturning of articulated tippers. In an attempt to prevent overturns, Bardon Aggregates installed CCTV cameras in the front-inside of the vehicle body. The image is then relayed to a monitor in the cab. The driver can now observe, visually, the loading and discharging operations from the safety of the vehicle cab, assessing if there is likely to be any danger of the lorry tipping.

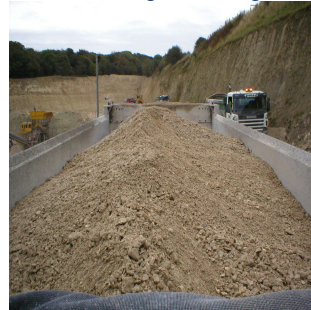
cctv image
