## BEST PRACTICE

LOCATION:	Quarry	ARTICLE YEAR	2006
ACTIVITY:	Access & Egress & Working at Height	COMPANY:	Aggregate Industries
SUB ACTIVITY:	N/A	COMPANY LOCATION:	Bardon Aggregates, Lancashire
BEST PRACTICE No:	BP365	COMPANY TEL:	07802 276 158
COUNTRY OF ORIGIN:	United Kingdom

**CCTV cameras reduce tipper overturns**

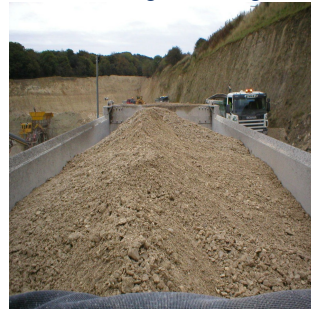
**cctv image**

One of the difficulties associated with the transportation and tipping of heavy loads is the overturning of articulated tippers. In an attempt to prevent overturns, Bardon Aggregates installed CCTV cameras in the front-inside of the vehicle body. The image is then relayed to a monitor in the cab. The driver can now observe, visually, the loading and discharging operations from the safety of the vehicle cab, assessing if there is likely to be any danger of the lorry tipping.
