BEST PRACTICE

LOCATION:	Asphalt/Coating plant	ARTICLE YEAR:	2013
ACTIVITY:	Maintenance & Housekeeping	COMPANY:	Aggregate Industries
SUB ACTIVITY:	N/A	COMPANY LOCATION:	Moorcroft Asphalt
BEST PRACTICE No:	BP895	COMPANY TEL:	07733 300271
COUNTRY OF ORIGIN:	United Kingdom

Clearing blockage using a Thermowrap system

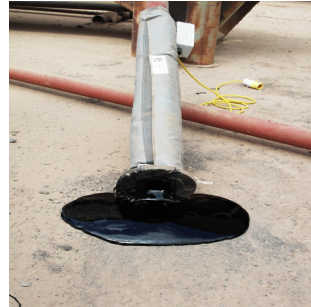
The solution has been to use the Bitumen Thermopipewrap System. This is a simple heated mat, inspired by Formula 1 tyre heater technology, it is wrapped around the item to be warmed, is fixed into position utilising a Velcro system and then plugged in to either 110v or 240v electrical feed. The Thermowrap heats up to the pre-set temperature and the solidified bitumen in the pipe, valve or pump then turns back into fluid state and flows out using gravity. The flow of bitumen is slight as the temperature rises so removal is under tight control at all times.

Moorcroft Asphalt Plant is using a novel solution for clearing blockages caused by cold bitumen. The traditional method was to use a naked flame to heat the offending pipe or valve and allow the product to drain under gravity. This exposes the operator to the risk of burns, spillages, fire, working at height and others. An alternative is to allow the pipework to go cold, disconnect and then either heating and cleaning out or replacing, this process has similar risks.

The method utilising the Thermopipewrap is safer, reduces downtime, and the cost of the item compared to traditional methods is vastly reduced.
