Bulk Tipper Trailer Ram Failure

LOCATION:	**LIME & SLAG PLANTS**	**ALERT STATUS:**	**Normal**
ACTIVITY:	**TRANSPORT & LOGISTICS / DELIVERY**	**DATE ISSUED:**	**12/10/2017 12:21:43**
SUB ACTIVITY:	**LOADING**	**INCIDENT No:**	**01473**

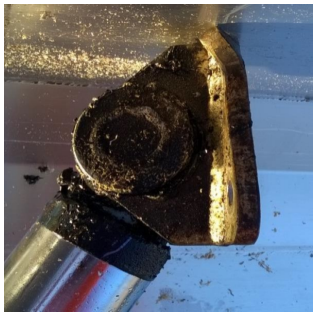
- 4 mechanical fasteners had failed (2 had sheared off and there was evidence of metal fatigue, 2 had stripped off nyloc nuts from threads)

- Two of the mechanical fasteners showed evidence of metal fatigue

Ensure that any inspection and maintenance regime, takes into account other critical components that are not part of a mandatory VOSA inspection regime; in this case, the ram top mounting fasteners.
