Lifting Chain Failure

LOCATION:	**OTHER**	**ALERT STATUS:**	**Normal**
ACTIVITY:	**LIFTING**	**DATE ISSUED:**	**06/02/2018 20:28:20**
SUB ACTIVITY:	**NO SUB ACTIVITY AVAILABLE**	**INCIDENT No:**	**01482**

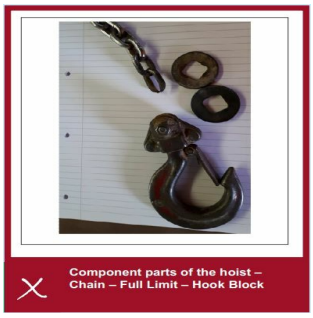
Hook Block

During a routine lifting operation, a chain link on the lifting hoist chain broke causing the item it was lifting to fall.

Examination revealed that the hook block had come away from the chain. The first link of the chain, that is normally inside the hook block, had worn causing it to fail. The hook block pin slid through and became separated from the chain. There was some wear on the opposite end of the link to the failure.

- All chains should be examined to ensure no noticeable wear on end links
- Ensure pre-use checks are carried out. Do not rely solely on the annual thorough examination
- Consider the amount of use and working environmental when deciding on a hoist's life expectancy before it is replaced.

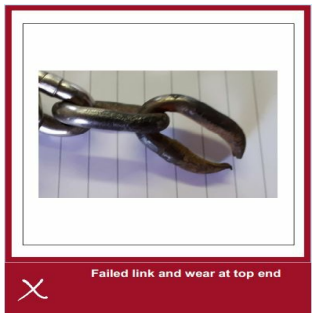
Failed Link

The hoist was rated with a safe working load of 250kg and was only lifting an item about 21kg. The hoist had been in service since 2002 and had a thorough examination certificate from Feb 2017 that did not identify any recommended actions in relation to the chain.
