Fatal 6 - HiPo: Scaffolder with no Fall Arrest Protection

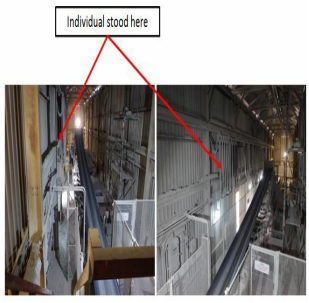
While supervising a team of scaffolders erecting a scaffold, the individual climbed over a walkway handrail onto and along a structural beam with no fall arrest protection (at around 3m height) - the action was a shortcut to complete the task due to a challenge with the job.

- the individual involved was a fully trained advanced scaffolder,

- all permits, risk assessments and method statements in place

- the individual was fully aware that his actions were against training, method statements and not compliant with Work at Height Life Saving Rules and safe working practices

Investigation Outcomes:
- Individual permanently excluded from company sites

- Scaffolding company to discuss the incident with their teams and review RAMS for future tasks

Actions to consider:
- Ensure contractors are regularly supervised while working on site

- Thoroughly scope out tasks before commencing work to understand potential challenges
