Fall from Tipper

LOCATION:	**CEMENT PLANT**	**ALERT STATUS:**	**Normal**
ACTIVITY:	**TRANSPORT & LOGISTICS / DELIVERY**	**DATE ISSUED:**	**25/06/2011**
SUB ACTIVITY:	**PRODUCT DELIVERY**	**INCIDENT No:**	**00290**

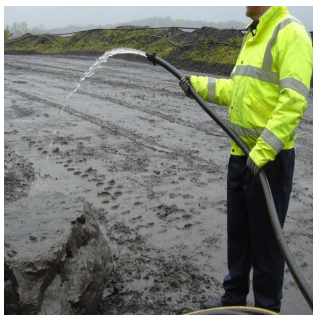
Picture 1: Pump Inoperative

On inspection, the water pressure at the wash station was not sufficient to allow the ‘jet’ of water to reach the full length of a tipper (picture No:1) and this may have been the reason why the wash station was not used. Further investigation found that the wash station boost pump had tripped, once reset the station operated as intended (picture No:2).

The supervision and control of contractors is paramount and where local rules are in place they must be enforced and policed at all times. All equipment must be suitable & sufficient for the task that it is intended.
