Angle Grinder Kick Back

LOCATION:	**CEMENT PLANT**	**ALERT STATUS:**	**Normal**
ACTIVITY:	**MAINTENANCE & HOUSEKEEPING**	**DATE ISSUED:**	**24/04/2013**
SUB ACTIVITY:	**N/A**	**INCIDENT No:**	**00364**

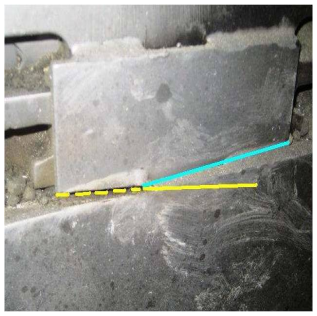
An experienced operator was using a 9 inch angle grinder to cut out lower stainless steel welding fillets in the clinker cooler.

As the operator approached the cooler wall he couldn't operate the grinder vertically, so moved to position where he was using it by holding the grinder horizontally. In order to access the last two welds he remained standing but stooped in order to hold the angle grinder in a more horizontal plane as the previously steeply inclined position could not be accommodated so close to the cooler wall.

During the use of the grinder horizontally, the blade snagged in the steel being cut and kicked back towards the user. As the grinder kicked back the rotating blade caught his left thigh, resulting in a laceration about 60mm in length and 25mm deep, that required immediate first aid and hospital treatment.

The use of 9 inch angle grinders was suspended until a full evaluation of the need to use this type of equipment has been made (and further 4½ inch angle grinders were sourced).

Subsequently if there is a call for the use of a 9 inch angle grinder, then a task specific risk assessment must be completed: and the 9 inch angle grinder will only be permitted for the use of that operation only.
