Failure of tipper's sheeting arm whilst driving on motorway

LOCATION:	ON-HIGHWAY	ALERT STATUS:	Normal
ACTIVITY:	TRANSPORT & LOGISTICS / DELIVERY	DATE ISSUED:	25/02/2015 00:30:20
SUB ACTIVITY:	ON-HIGHWAY	INCIDENT No:	00405

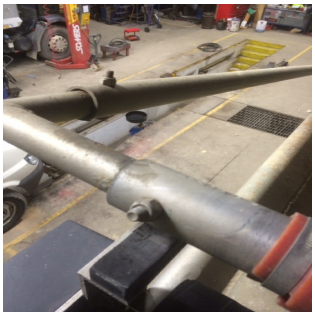
Figure 1

On later inspection it was found that the spilt pin had sheared and the washer had fallen off.

The bottom end of the sheeting arms and the attached springs are held on the mounting spigot by a large washer and split pin (see figure 1). The sheeting arms on either side of the body are joined together by a cross member bar which is attached by an elbow joint on either end (see figure21). The sheet/net is also attached to this cross member at one end and to a spindle at the headboard which is operated by the sheeting motor.

refuge next to the hard shoulder. On inspection he immediately noticed that the sheeting arm had actually become detached from the mounting point and was on the carriageway. On later inspection it was discovered that the split pin had sheared and the retaining washer had fallen off.

Immediate:
All vehicle sheeting systems visually checked and drivers instructed to ensure sheet is in closed position when vehicle not in use. This will prevent the springs from being under prolonged tension and enable drivers to carry out more extensive checks.

Mid & long-term:
Discuss incident report, together with design and use procedures, with the system manufacturers. Investigate the fitting of side to side automatic sheeting systems on new vehicles.
