TRANSPORT - Fatal 5 - Whilst attempting to tow a stuck mixer truck a chain snapped striking the vehicle.

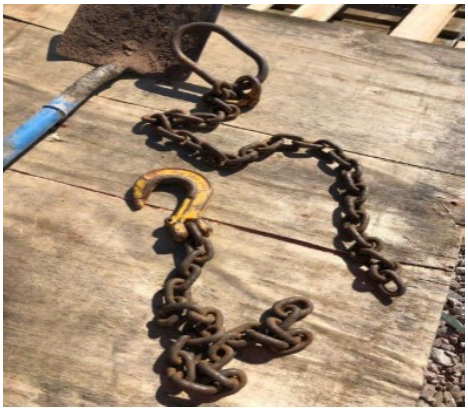
On the initial towing attempt, a single chain was utilised. Under tension, the chain failed and snapped, propelling a section of it through the air. The chain struck the mixer vehicle's windscreen directly in front of the driver's seated position. A subsequent attempt was made using multiple chains; however, one of these also failed under load.

As a result of these incidents, the mixer vehicle sustained damage to both the external sun visor and the windscreen. This incident could have resulted in an injury to an individual if they had been struck by the chain.

- No Risk Assessment carried out to determine hazards and controls.
- No procedure in place for the self-recovery of the vehicle.
- Lack of information, instruction and training provided to the driver.
- Incorrect equipment used to recover the vehicle.

The images below show the broken chain and the damage to the vehicle.

- Towing of stranded vehicles shall only be carried out by competent persons following a robust Risk Assessment & Method Statement using only approved equipment. Chains or ropes must never be used for towing.
- Working group to create a safe self-recovery procedure.
- Driver onboarding schedule updated to include towing restrictions along with annual refresher training and driver pack.
- Safety tags added to towing eyes to prompt management contact and requirement for a Risk Assessment prior to use.
