BEST PRACTICE

LOCATION:	**Concrete products plant**	**ARTICLE YEAR**	**2016**
ACTIVITY:	**Guarding and isolation**	**COMPANY:**	**Creagh Concrete Products Ltd**
SUB ACTIVITY:	**No Sub Activity Available**	**COMPANY LOCATION:**	**Toomebridge**
BEST PRACTICE No:	**BP1975**	**COMPANY TEL:**	**0000**
COUNTRY OF ORIGIN:	**United Kingdom**

Edge Protection system

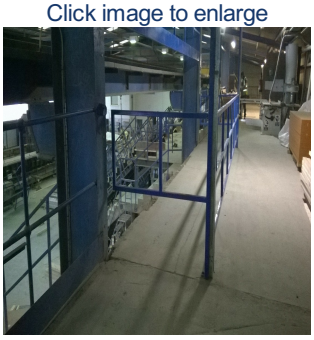
A potential falls from height risk was identified at Creagh's precast stair factory.

A raised, mezzanine area at first floor level is used to build moulds for the casting of the precast stairs. Large pallets of timber are delivered to 2, designated loading bay areas on the mezzanine floor. A forklift truck raises the pallets from ground floor to the loading bays. Handrails were in place along of the edge of the mezzanine area but there were gaps by the loading bays to provide access for the forklift. Large straps were tied cross the opening to prevent a fall from height. However, this still left operators at risk as the bays were unguarded during loading, it also relied on the operators to attach the straps after every use.

To address this risk, the managers at the site developed a counter balanced barrier system, when 1 barrier was lowered and the other was automatically raised or vice versa. The weight of 1 barrier mirrors the weight of the other, they are connected by a pulley system. The system is very easy to use. Normally, the edge barrier is deployed, when loading however, this is lifted and the loading bay area barrier is lowered into place.
