TRANSPORT - Fatal 6 - Debris stuck in a lorry's wheels was dislodged while driving on-highway and struck windscreen of another vehicle.

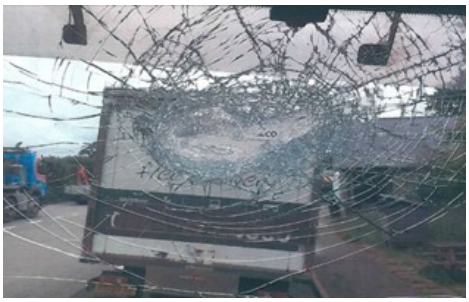
A company received a complaint that a brick had fallen from one of its vehicles and damaged the windscreen of another truck when driving on the public highway. On investigation, using the 3rd party truck footage, it was evident that the brick came from under the company's vehicle and not from the load area.

Further investigation revealed that the truck had run over some brick debris at the delivery point. A brick had lodged between the twin wheels on the drive axle of the vehicle, this was dislodged when the vehicle was traveling at speed on the motorway. This incident could have resulted in a fatality.

The images below shows an image of the debris in the yard and the damage to the windscreen

- Good basic housekeeping is a must in all our yards. We all look out for slip trip risks on a walkway, but now we are asking for your help to look out for the route the vehicles take to help keep these areas clear of debris.
- Drivers, please take care when maneuvering on site to not run over discarded bricks.
- If the above cannot be avoided and you are unable to move them, alert the yard manager or the nearest operative if you can.
- If you are left with no choice other than to drive over debris, check the space between the twin wheels before leaving site and only if safe, remove what you can or ask for advice / assistance from your ATM.
- If you require any further information, assistance or guidance please contact your Area Transport Manager.
