Fatal 1 – Fatal machinery crush incident on conveyor system – MP Connect Alert

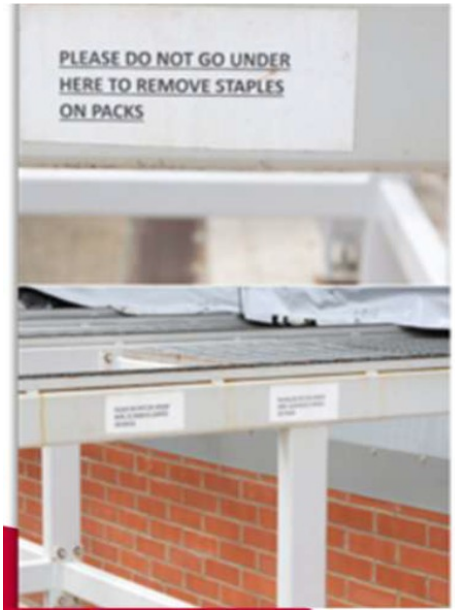
- Access to a dangerous part of machinery was routinely occurring, despite the company being aware of the unsafe practice.
- The company relied on signage and instruction alone to prevent entry into the conveyor danger zone.
- CCTV evidence showed operative accessing the conveyor framework on at least 19 occasions in the weeks leading up to the incident.
- No close or distance guarding was in place to prevent access.
- The system of work required employees to access dangerous parts of the conveyor to remove packaging.
- This system was only changed after the fatality.
- The company was fined £2.2??million plus costs

The image below shows the signs that were on the conveyor system.

• Undertaking suitable and sufficient work equipment risk assessments.

• Applying the hierarchy of control, prioritising engineering controls over instruction.

• Designing tasks to eliminate the need to enter danger zones.

• Using robust machinery isolation (LOTOTO).

• Audit guarding arrangements to ensure dangerous parts cannot be accessed.
