Operative Struck by Roller

LOCATION:	ON-HIGHWAY	ALERT STATUS:	Normal
ACTIVITY:	PRODUCTION AND PROCESSING	DATE ISSUED:	13/03/2015 11:54:14
SUB ACTIVITY:	ASPHALT & COATED STONE	INCIDENT No:	01409

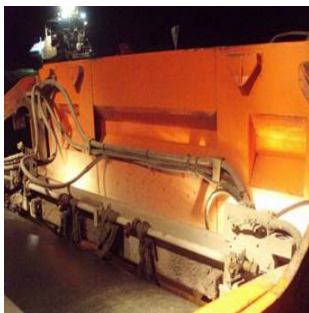
- The existing front headlamps on the roller were not isolated when the grit box attachment was fitted to the roller. This resulted in lighting glare reflecting back into the roller cab further impairing the drivers vision.
- The operative was under the misapprehension that the roller driver was aware of his presence.
- The operative and the roller driver failed to adequately communicate with each other which resulted in neither of them knowing what the other was doing.

Front Lights Not Isolated
