Operative Struck by Roller

INCIDENT No:

01409

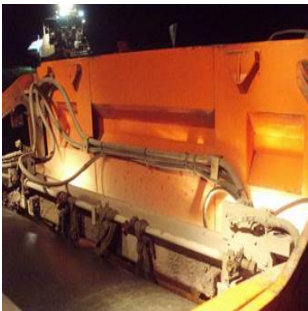
- The existing front headlamps on the roller were not isolated when the grit box attachment was fitted to the roller. This resulted in lighting glare reflecting back into the roller cab further impairing the drivers vision.
- The operative was under the misapprehension that the roller driver was aware of his presence.
- The operative and the roller driver failed to adequately communicate with each other which resulted in neither of them knowing what the other was doing.

Front Lights Not Isolated
