BEST PRACTICE

LOCATION:	Quarry	ARTICLE YEAR:	2004
ACTIVITY:	Maintenance & Housekeeping	COMPANY:	Hanson Aggregates
SUB ACTIVITY:	N/A	COMPANY LOCATION:	Allerton Park Quarry, Harrogate
BEST PRACTICE No:	BP122	COMPANY TEL:	01423 323311

TITLE	💿 On Video
Battery charging station	
ARTICLE	
A risk assessment for charging batteries at this Knaresborough quarry identified that a new charging needed with the following criteria:	station was
L protection for operatives should there be an ignition of gases L good ventilation

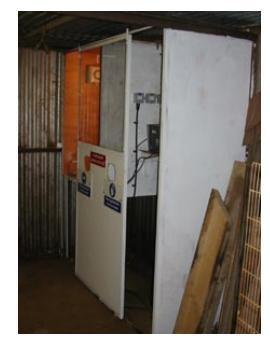
battery charging station

Thus a well-ventilated charging cabinet with twin compartments was installed. The battery to be charged is placed on one side of the cabinet, with the charging equipment and electrical switchgear on the other. An extractor fan mounted in the battery-charging compartment provides ventilation.

A sliding door made from a shatterproof plastic draws across the front of the cabinet and allows only one of the two compartments to be open at any time. The top compartment is a window to view the operation and the lower part contains two hand holes that enable the charger grips to be connected and disconnected from the battery with the operator safely behind a protective screen. The power to the charger is only turned on or off with the door closed.
