## Danger of using the wrong disc on angle grinders

LOCATION:AGGREGATE DREDGERACTIVITY:MAINTENANCE & HOUSEKEEPINGSUB ACTIVITY:N/A

ALERT STATUS: DATE ISSUED: INCIDENT No: Normal 11/10/2017 11:27:09 01472

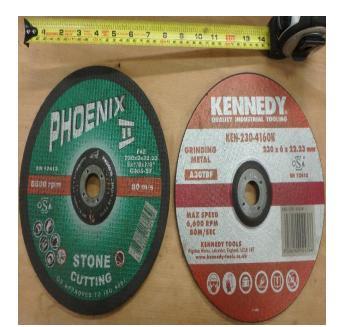
The Chief Engineer on board a marine aggregate dredger was in the process of carrying out a stock take of cutting and grinding equipment. During this check, two cutting discs were found that were designed for cutting stone, a task which is unlikely to be necessary on board. It was assumed that the discs had been purchased and/or received in error.

Due to strong centrifugal forces, it is probable that if stone cutting discs are incorrectly used for cutting steel, they would overheat and shatter, or due to the unintended cutting material, a kick-back would occur, where the angle grinder is violently thrust back. Both results have the potential to result in serious personal injury.

Image shows difference in discs

- On every occasion when using an angle grinder, ensure the cutting disc is appropriate to the material intended to service. Be aware that there are four main types of cutting disc design: steel, stainless steel, aluminium and stone.

- Ensure all cutting discs on board are manufactured to standard: EN 12413. This is a strict safety standard with specified requirements for bonded abrasive products. All discs should be clearly marked to reflect this.

- Cutting discs should be inspected prior to use to ensure they are within their age expired date (typically three years from date of manufacture). This should be clearly marked on the metal centre ring.

- If carrying cutting discs of varying intended designs, segregate these as much as possible.
- When working with cutting discs particular attention must be taken when handling them as the severity of a chip or crack can intensify rapidly when spinning at 80m/s.
