WHAT HAPPENED

LOCATION: ACTIVITY: SUB ACTIVITY: READYMIX OR MORTAR PLANT MANUAL HANDLING AND STORAGE N/A ALERT STATUS: DATE ISSUED: INCIDENT No: Normal 27/11/2012 00345

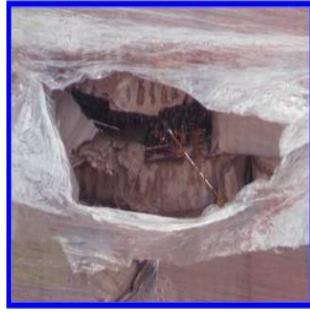
The employee had been given the task of loading truckmixers with the fibres, emptying them from cardboard boxes onto a mobile conveyor. The boxes had been stored outside on pallets under plastic covers. Due to heavy rain the boxes had become soft and were breaking down, causing the fibres to spill onto the ground.

Damaged Boxes

•Are materials stored correctly on site?

• Is housekeeping maintained to a high standard with weather conditions accounted for?
