Fatal 5 - Operator sustains finger injury after being trapped whilst assisting with the unloading of bags using a telehandler

LOCATION: DEPOT ACTIVITY: LOADING AND UNLOADING SUB ACTIVITY: NO SUB ACTIVITY AVAILABLE ALERT STATUS: DATE ISSUED: INCIDENT No: Normal 09/08/2023 19:55:29 03658

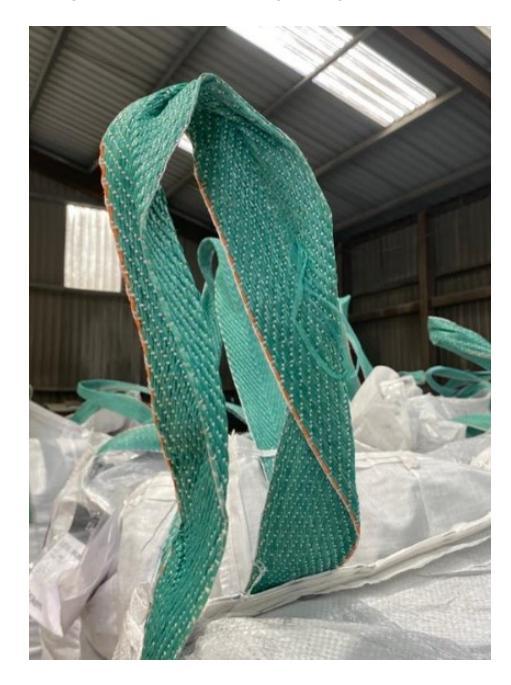
A telehandler operator was unloading a micro-silica delivery and transporting 1.2 tonne bulk bags. After 8 bags had been successfully off loaded and stored, the 9th bag fell off the pallet and onto the floor; each bag has four loops / straps, two of which got caught half underneath the bag.

Image shows a bulk bag lifting loop.

- · Ensure loads are secure before attempting to transport them
- Only use suitable vehicle access routes
- Enforce exclusion zones around operational mobile equipment
- Stop & Think and Take 5 in event of unexpected circumstances

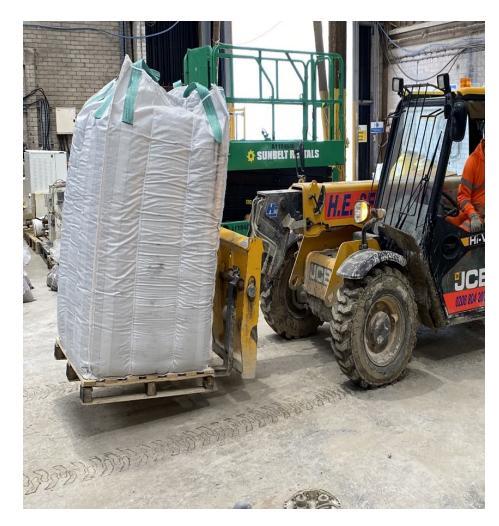
During this process, the straps became taught, trapping the injured person's third finger on his left hand. As the pressure came on the injured person pulled his hand away, leaving his glove and the very end of his finger trapped under the strap, resulting in an open fracture of the bone.

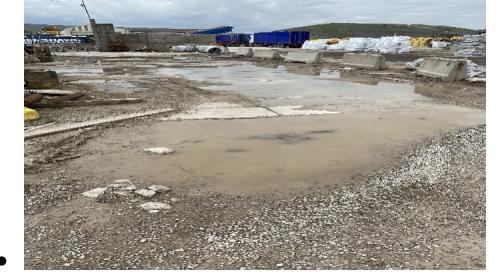
· Incorrect route taken to transport load as regular route was blocked by other vehicle - image shows route
