BEST PRACTICE

2022 Tillicoultry Quarries Ltd Northfield Qu\rry 0000

Lithium battery - Recharger cabinet

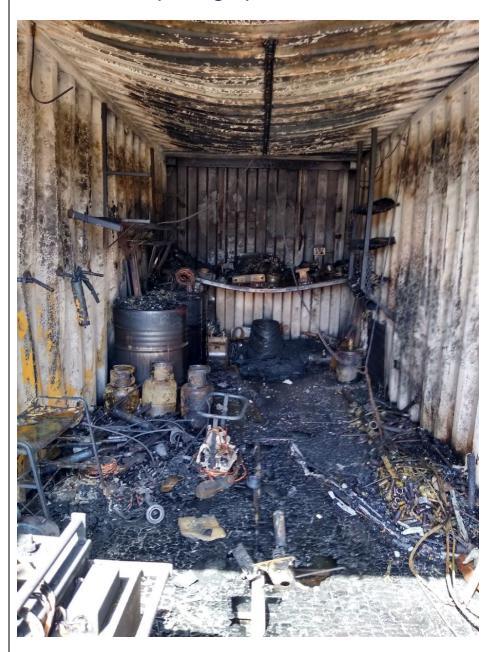
An incident occurred at one of our quarries involving a battery powered impact gun. One of the operators put the battery onto charge in the tool store, which was located in a steel container. Two hours later it was recognised that smoke and visible flames were coming from tool store, the emergency services were called, and the power isolated. The photograph demonstrates the exact nature of the damage created.

- The incident occurred at the charging point for the impact gun charger / lithium-ion battery.
- The impact gun is powered by an 18-volt lithium battery that is charged within a stand-alone 240v charger unit.
- Plant operator put the battery onto charge in the tool store in an 20ft steel container, no defects with the charger or battery were noticed on the pre-charge inspection.

It was situated on a metal shelf and the charger was plugged into 240v internal fitted 3 pin socket which was used on a regular basis with no issues or faults reported.

Following the above incident it was discussed, at an internal business meeting, how this could be avoided in the future. One of our quarry managers engaged with their quarry engineer to fully review the incident to formulate ideas to prevent a reoccurrence.

The engineer carried out a risk analysis of charging these types of batteries and started to look at the Hierarchy of Control. The charging of batteries could not be eliminated or substituted as returning to mains cabled power tools in a quarrying environment was reintroducing risk to the operations that had been eliminated with the introduction of battery powered tools.

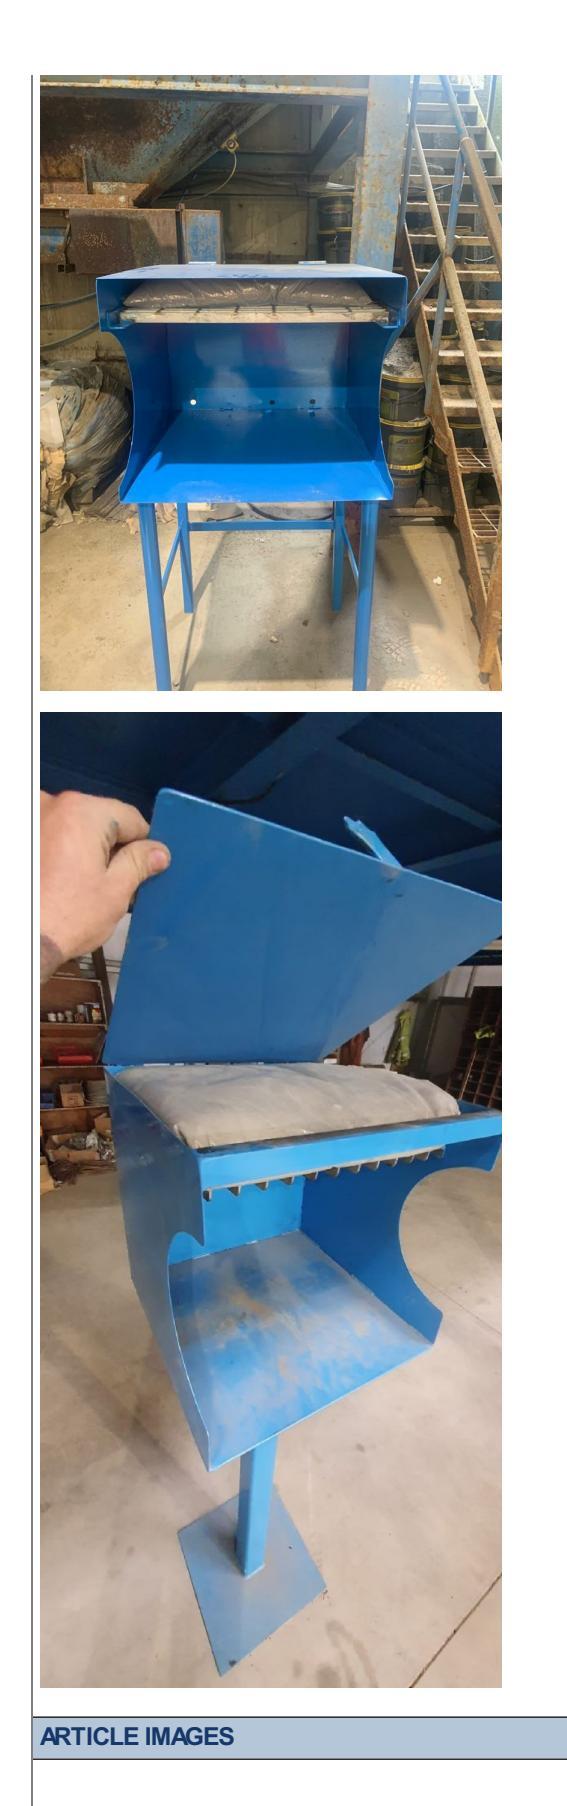
Please see the **additional pdf**, the images below and the video to find out about the solution developed to reduce the risk of fire when re-charging the batteries.
