Mixer Truck Nip Point

ALERT STATUS: Normal
DATE ISSUED: 05/03/2015 12:13:19
INCIDENT No: 00407

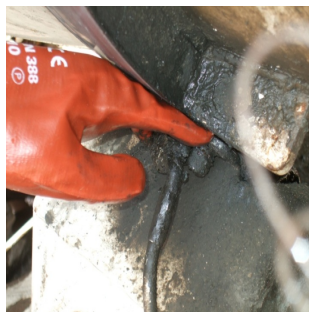
Nip Point

In a recent incident a truck mixer driver, working for an Independent Haulage Contractor, was lucky to escape more serious injury when he decided to grease the moving track ring of his drum with his gloved hand. His finger was trapped by the drum locking mechanism, resulting in the loss of his finger tip.

- The truckmixer was originally fitted with a remote greasing facility, incorporating a tangential plate and grease hose, allowing the track ring to be greased from ground level, away from the risk of entanglement; however the plate had been damaged and removed and the hose tucked out of the way. Is plant and equipment formally inspected? Are defects reported and repairs carried out promptly? Where necessary are interim precautions implemented to prevent injury?

- There was no written Safe System of Work for the activity and the truckmixer drum was moving at the time. Are documented Safe Systems in place for maintenance activities? Do they include the need to isolate all live / moving plant and equipment before undertaking any maintenance?

- The driver had been inducted and had seen the previous Safety Alert. Do we learn from previous incidents, reviewing Safety Alerts with employees and contractors and ensuring necessary preventative actions are in place? Do we apply our training and remember to Stop & Think before undertaking new activities particularly where there

- How many times had this practice been carried out before? Are employees and contractors aware of the need to look after themselves and each other, and “step in” if they see someone completing a task in an unsafe way?
