Bitumen Burns caused by Slip Trip Fall

LOCATION: ON-HIGHWAY
ACTIVITY: PRODUCTION AND PROCESSING
SUB ACTIVITY: ASPHALT & COATED STONE

ALERT STATUS: Normal
DATE ISSUED: 10/11/2015 18:16:27
INCIDENT No: 01421

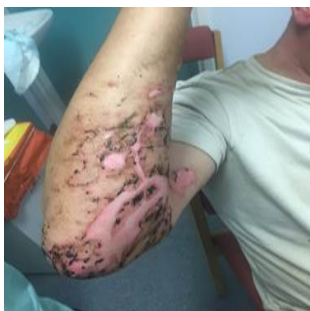
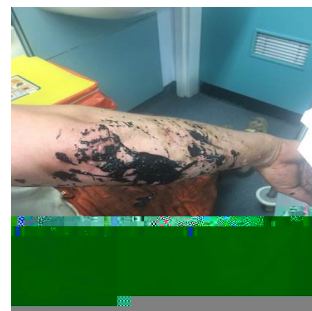
Whilst carrying out work sealing joints with hot pour, an operative received burns to his right forearm following a trip on some break out material.

The Injured Party (IP) involved in the incident had safely poured three cans of hot pour to joints, When he had filled the fourth can, he stepped back from the pickup and lost his footing. This made him drop the can of hot bitumen which resulted in bitumen spilling up his right arm Hi-Vis sleeve and into the gauntlet.

The IP was deemed as competent to carry out the task and had been issued with P.P.E including gauntlets that reached half way up his forearm.

Ensure all activities are fully planned and, if hazards are identified, control measures must be reviewed.

Always consider using alternative method of sealing joints i.e. cold pour. If this is not an option, the following should be considered;

- Where hot pour operations are undertaken a Permit to Work must be issued detailing the correct procedure to be followed, including competent operative deployed and full P.P.E. requirements.
- Ensure the correct P.P.E. is available and worn at all times, this must include gauntlets that protect the entire arms and / or Kevlar sleeves and Gauntlets.
- Ensure the work area is kept clean and tidy and ensure the work area is adequately lit in hours of darkness.
