Train Derailment

LOCATION: RAILHEAD
ACTIVITY: TRANSPORT & LOGISTICS / DELIVERY
SUB ACTIVITY: RAIL

ALERT STATUS: Normal
DATE ISSUED: 02/05/2017 09:58:22
INCIDENT No: 01450

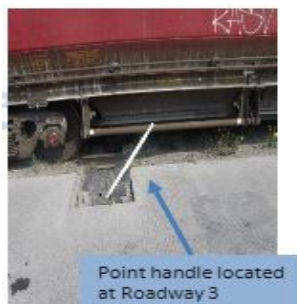
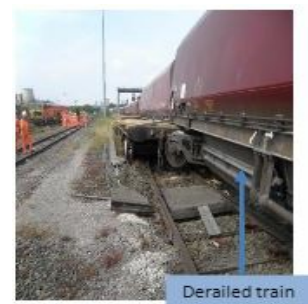
Two employees, carrying out a safety tour, entered a rail loading area and approached the location where the lever that operates the railway points is positioned. There was a roadstone train parked on the track, awaiting permission to leave the site. The employees spotted the point's lever and thought that the area around the lever could be a trip hazard. At this moment one of them moved the lever, however they were unsure if their actions affected the points on the track, so they decided to move the lever again, whereupon the points did move, changing the track from one line to another. The employees tried to seek assistance, however at that moment the train pulled away, causing a number of wagons to derail from the track. The employees were on a planned health and safety tour to identify hazards across the site for discussion in the following health and safety committee meeting - Neither of the employees had any rail safety training and were not authorised to operate the lever. - All track inspections had been completed monthly, there is no evidence to show the points were faulty.

HOW COULD THIS INCIDENT HAVE BEEN AVOIDED? - Restrict access to sidings to authorised personnel...only trained / guided employees to be allowed in loading areas. - Increased signage at point locations, identifying no unauthorised usage. - Shield point levers to deter unauthorised access / use. - Train all employees in basic rail safety, including prohibited activities. KEY REVIEW POINTS: - ASK YOURSELF are you authorised / safe to enter restricted areas of a factory / yard? Seek authorisation to enter unfamiliar areas and, where required, ensure you are accompanied by an authorised person. -THINK before you operate plant or equipment, are you trained and authorised? - Ensure your ACTIONS are not going to affect the Health and Safety of others. - If in doubt always SEEK ASSISTANCE from trained personnel. - Are personnel aware of all HAZARDS on site? - Always Look After Yourself and Each Other... please STEP IN if you see anyone acting unsafely.
