INCIDENT ALERT

LOCATION: CONCRETE PRODUCTS PLANT
ACTIVITY: MANUAL HANDLING AND STORAGE
SUB ACTIVITY: CONCRETE PRODUCTS

Product Storage

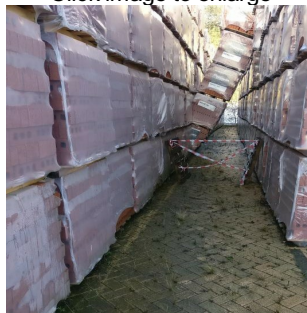
A recent incident involving the storage of clay bricks has learning points which apply across most industry sectors. A stack of product recently became unstable and collapsed. Due to the close proximity of other stacks the load remained upright but became a significant hazard. An investigation identified that both ground conditions and rotten pallets were contributory factors.

- All storage of heavy building products poses a potential risk.
- All product should be stored in accordance with a formal standard operating procedure or safe working practice.

- All stored product should be regularly inspected.
- Any unstable products or stacks must be appropriately controlled (cordoned off) until they can be safely addressed. (Editors note: See also HSE Guidance on Pallet Safety PM15: Stack height depends on the height, strength and stability of the unit loads, and the ability of the operator to see clearly. Only build taller stacks after detailed consultation with the manufacturer or other competent authority, and the maximum height should be no more than six times the narrowest dimension of the bottom pallet. This is provided that: • you have carefully assessed the block stacking pattern and the compression characteristics of the payload; • the pallet itself is designed to meet the stacking height required).
