# Confined Space - Serious Near Hit

LOCATION:	AGGREGATE DREDGER
ACTIVITY:	MAINTENANCE & HOUSEKEEPING
SUB ACTIVITY:	N/A

ALERT STATUS:	Normal
DATE ISSUED:	19/02/2019 10:32:13
INCIDENT No:	01505

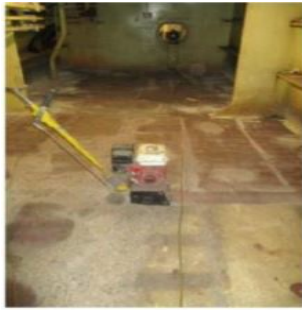
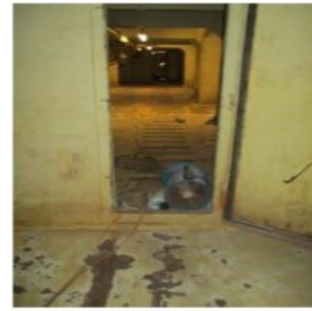
The task involved using a power scarifier to clear paint and rust from steel surfaces. The tank was gas free and certificated before work commenced with a yard entry certificate running for 24 hours. Initially the contractors used an electric 110v scarifier unit, but as they moved along the voids they encountered power drop issues on the electric unit with the length of power leads used. The contractors changed from the electric motor unit to a petrol engine unit and continued working throughout the day.

On leaving site they reported feeling dizzy and unwell and visited the local hospital, where they were found to have high carbon monoxide blood readings and were placed on oxygen for 2 hours before being discharged. The carbon monoxide was created from the exhaust of using a petrol machine in an enclosed space.

- No company personnel were informed of the near hit until the following day;
- Risk assessment did not include the use of power tools or the petrol scarifier;
- The permit issued from the yard did not include petrol equipment.
