Contractor loses 4 fingers during lifting operation - £400K fine for company

READYMIX OR MORTAR PLANT

01527

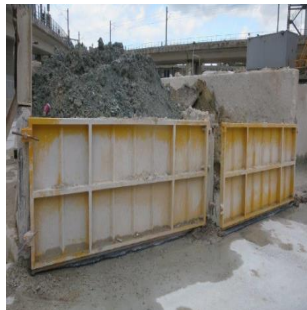
A site maintenance manager instructed a contractor to fabricate three new gates for some waste material bays at a readymix plant. The contractor and a colleague were fabricating the 3rd of the 3 gates at the plant (see pictures below). Whilst trying to flip the metal gate over using a fork lift truck and lifting chains, the metal gate slipped and trapped one of the contractor's fingers on his right hand.

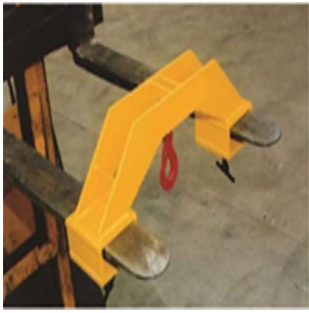
Correct lifting device

- Ensure attachment (picture example below) is used when using slings or chains on FLT to prevent the load from moving.
- Ensure there are clear procedures / processes on site to prevent unauthorised access to mobile plant. Where contractors are required to use items of mobile plant, a copy of their competencies MUST be held seen on induction.

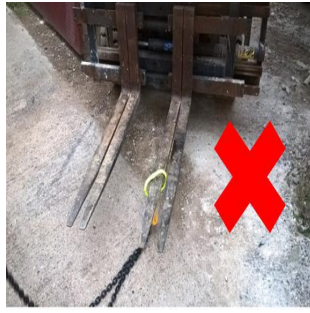
Sixth opportunity to stop this incident All lifting operations MUST have a Lift Plan which details any lifting attachment required. The investigation revealed the following; That no lift plan had been completed for the lifting operations to flip the muck gate over. As a result of this, the correct equipment was not selected for the lifting and slinging of the muck gate. One of the contractors was a trained lifting and slinging operator. The P2P identified lifting and slinging, but the absence of the lift plan was not challenged when issuing the P2P. Inappropriate lifting equipment was used to sling the muck gate, using chains with no FLT slinging attachment. The lifting chains were attached to the FLT forks (see picture below) which allowed the muck gate to slip when the forks were lifted.

Lifting device used in incident
