# Truck Mixer Driver suffers Amputation

LOCATION:	CONSTRUCTION/DELIVERY SITE	ALERT STATUS:	Normal
ACTIVITY:	TRANSPORT & LOGISTICS / DELIVERY	DATE ISSUED:	22/08/2011
SUB ACTIVITY:	PRODUCT DELIVERY	INCIDENT No:	00309

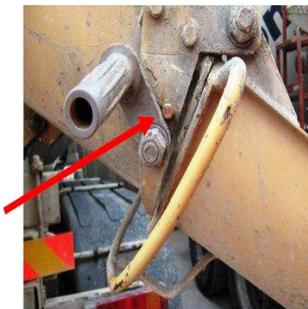
Shute with Bolt

The use of a small bolt to prevent the safety catch handle over rotating is being raised with the manufacturer of the mixer.

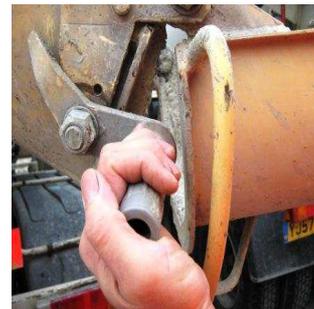
A truck mixer driver received crushing injuries resulting in the amputation of part of his little finger when the two handles in the picture came together when he operated the chute.

The bolt highlighted was missing and had not been replaced. This allowed the round bar handle on the second (lower) chute to impact against the safety catch handle on the upper chute which resulted in the injury.

Shute with Missing Bolt

Ensure regular inspections are carried out.

Report all defects.

Ensure that remedial or repair work is promptly completed.
