Load security

ALERT STATUS:	Normal
DATE ISSUED:	09/01/2013
INCIDENT No:	00355

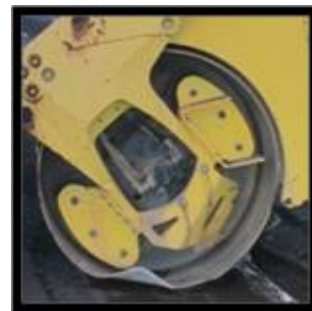
A 10 tonne Bomag 161-AD4 tandem vibratory roller slewed off a low loader trailer during a short journey from a compound to the site. The incident did not result in injury, but could quite easily have led to multiple fatalities as the machine came to rest on a pedestrian footway.

Considerable damage has been caused to the machine amounting to thousands of pounds. Whilst an in depth investigation into the events surrounding the incident is underway, initial findings cite the use of inappropriate restraining devices and the recommended machine tie down points not being used.

- Drivers are trained in loading and securing plant and machines:
- Appropriate restraining devices are used:
- they are checked before use for defects:
- they are capable of withstanding the load to be secured:
- The recommended tie down points are used on the machines:
- The recommended tie down points on the trailer are used:
- Whether it's a long or short journey, make sure it's secured properly.
