INCIDENT ALERT

LOCATION: CEMENT PLANT
ACTIVITY: MAINTENANCE & HOUSEKEEPING
SUB ACTIVITY: N/A

Dumper Driver Crush Injuries

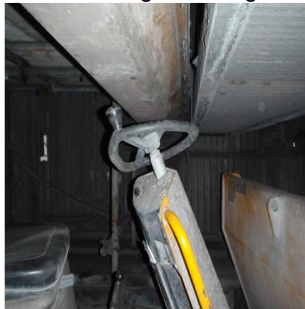
The driver had transported one load of sweepings to a recycling point and was carrying out a three stage manoeuvre in the building to position the skip under the fixed chute. Whilst reversing he lost control of the vehicle, travelling further back than intended and became crushed between the dumper steering wheel and the casing of an inclined screw conveyor directly above him. He received injuries to his chest and knee.

Dumper Close Up

The vehicle roll over protection bar had been folded down to access the building but had not been put back up once inside: Whilst not designed to protect against this type of incident, in this case it would have prevented injury. Are drivers trained to return the roll bar to the correct position as soon as possible?

There was limited space to manoeuvre the dumper to position the skip under the chute: Do we consider methods of work that avoid the need to take vehicles inside buildings? Are specific risk assessments carried out and control measures applied for the use of vehicles inside buildings or in restricted spaces? Are teams trained in these assessments and are the controls enforced through supervision? Are vehicles suitable for use in buildings?
