## INCIDENT ALERT

**LOCATION:** CEMENT PLANT  
**ACTIVITY:** MAINTENANCE & HOUSEKEEPING  
**SUB ACTIVITY:** N/A

**ALERT STATUS:** Normal  
**DATE ISSUED:** 01/08/2013  
**INCIDENT No:** 00368

**Battery Explosion**

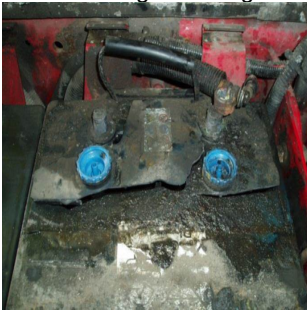
An LGV vehicle battery top exploded when the hydrogen gas it was venting, was ignited by sparks, caused by a spanner accidentally touching earth.

What happened: A contractor was carrying out a modification to a catwalk. As this work involved welding to the chassis, the battery was disconnected. Once the work was completed the battery was reconnected, and the spanner accidentally touched the chassis, causing an arc. This in turn ignited the hydrogen venting from the battery, causing it to explode.

Disconnecting/reconnecting the positive (+) terminal, of the battery is not considered the correct method, as any contact with an earth will cause a spark.

If the negative (-) was disconnected first then any accidental touching of the chassis would not result in a short circuit. Always remove the negative (-) terminal first!

It would not be expected for a battery to give off gas when not being charged, however in this instance the vehicle was started and moved into the workshop, this will have drained the batteries and caused the vehicle to start charging.

Once in the workshop the positive (+) terminal was disconnected, and the batteries were covered with rags to protect them from welding/cutting & grinding. It is possible that the rags did not allow the gas to dissipate and built up during the time it took to carry out the modification. Never cover the batteries with rags, should the batteries need protection, replace the cover, or remove them.
