# Hydraulic injection injury to hand and arm whilst using a hand held grease gun

## Liebherr Safety Alert

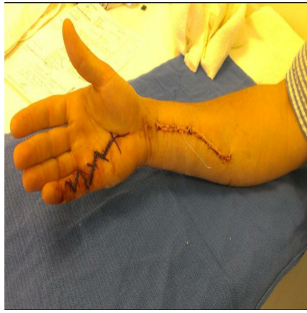
An operator was attempting to remove a hand grease gun from a grease nipple after pumping several times and finding it hard. Whilst gripping the hose and manoeuvring it, the hose ruptured and injected grease into his little finger.

He only felt a sharp prick to his little finger and on inspection, he noticed a small hole. On squeezing his finger approximately one teaspoon of grease was ejected. He was not wearing gloves at the time.

- Inspect equipment prior to use to ensure it is in sound working order with no cuts or damage.
- Check and tighten fittings
- Wear suitable protective gloves when using any equipment with stored energy potential.
- Even relatively low pressure equipment has the potential to inflict hydraulic injection injury
- Grease gun hose was not a strengthened hydraulic pressure (woven/mesh) type but of a rubberised compound only.
