## INCIDENT ALERT

<b>LOCATION:</b>	<b>OTHER</b>	<b>ALERT STATUS:</b>	<b>Normal</b>
<b>ACTIVITY:</b>	<b>MAINTENANCE &amp; HOUSEKEEPING</b>	<b>DATE ISSUED:</b>	<b>22/01/2015 15:25:47</b>
<b>SUB ACTIVITY:</b>	<b>N/A</b>	<b>INCIDENT No:</b>	<b>00398</b>

**Hydraulic Pressure Release**

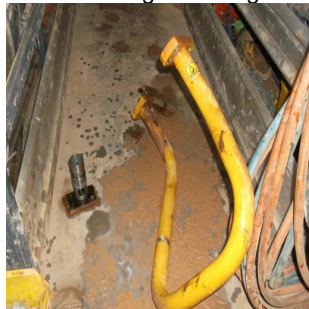
An employee maintenance fitter was removing a metal hydraulic pipe from a CAT365 Excavator boom after it was found to have a small hole in the pipe leading to loss of hydraulic fluid. The intention was to carry out a welded repair to the pipe and for this to be done safely it needed to be removed from the machine.

It was subsequently found that a check valve within the housing prevented release of pressure when the flexible hose was disconnected but the stored pressure was released on removing the metal pipe from its mounting. Furthermore there is a standard procedure for releasing all stored energy from the hydraulic system that is known to the manufacturers and their agent's experienced fitters but may not be known by "In House" fitters who do not work on mobile plant as often.

**Metal Pipe Removed**

Modern mobile plant often has quite complex hydraulic pressure systems with numerous circuits. In the case of machines with lifting capabilities there will be check valves and other safety features fitted to prevent any failure in the system leading to a falling boom or jib. As machines have become more complex it is unlikely that the training of "in company" fitters has kept pace with the modifications seen in recent years and they are therefore unlikely to be able to know how to safely isolate energy sources on all different types of machine.

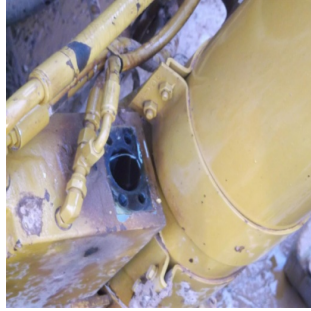
The employee had turned the machine off and placed the boom on the ground before proceeding to release pressure from the hydraulic system by removing the hydraulic tank cap and moving the lever for the boom. The IP then undid the flexible pipe from one end of the metal pipe which led to the release of some hydraulic oil but not under pressure. When releasing the final bolt at the other end of the metal pipe mounting there was a release of pressure causing the pipe to come away with force. As the IP was holding a ring spanner on the bolt the force was sufficient to cause a fracture to his wrist as the pipe was forced away from the mounting.

**Mounting Point of Metal Pipe**

- Are isolation points clearly identified?
- Are all potential sources of energy considered when isolating equipment?
