## BEST PRACTICE

| ACTIVITY: | Manual handling and storage | COMPANY: | CEMEX Rail Solutions |

#### Wire strand turning device

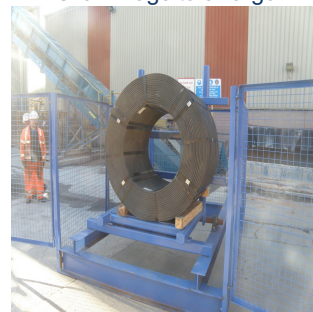
In consultation with the works team and a local fabrication company, a turning device was designed which enabled the coil to be rotated to an "eye up" position and have room for the forks to be removed from below without any scraping. The turning device is driven by a motor, guarding surrounds the turner and a safety bar stops the coil from hitting the guard. The guarding can be opened on all 4 sides allowing easy access. A fork lift with a metal "C" hook attached removes the coil from the turning device and places it safely in the strand dispensing unit.

CEMEX Rail Solutions recognised problems with the handling of wire strand coils. The issue was the rotation of coils lying flat on the ground to an upright position before loading into the dispenser. The existing process involved slipping a cloth strap below the coil and attaching the other side to a hook on a fork lift truck which would then lift the coil. During the process the bottom of the strand coil would scrape along the ground. BPCF'S guidelines also highlighted that cloth straps could deform the strand which could cause further safety issues.
