| LOCATION: | Concrete products plant | ARTICLE YEAR | 2016 |
| BEST PRACTICE No: | BP1950 | COMPANY TEL: | 0000 |

**Improving access to Penta tumble drum for maintenance works**

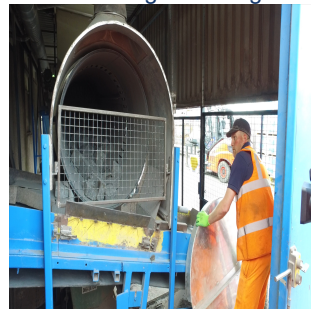
**After**

A pair of interlocked sliding doors were fitted to replace the solid enclosure guard at the discharge end. A lightweight aluminium discharge cowl was constructed. Following plant isolation and lock-off, the new cowling can be easily removed by a single fitter and stored safely to the side. Once removed, the tumble drum can be accessed using portable steps and the whole length of the drum can be easily seen by the 'topman' positioned at ground level.

- Significantly better access route and working conditions
- Operator can be seen at all times
- An individual can be recovered quickly and safely if required
- Ventilation of the drum during hot-work is improved
- Working at height has been reduced from 3.5m to 1.2m
- Easier to get equipment and parts into the drum
- Reduced risk of manual handling or crushing/trapping injuries
- Inspection and repair time has been halved
- Modifications cost £3,700 and completed in 2 days.
