INCIDENT ALERT

LOCATION: CONCRETE PRODUCTS PLANT
ACTIVITY: GUARDING AND ISOLATION
SUB ACTIVITY: NO SUB ACTIVITY AVAILABLE

Trap points on machinery

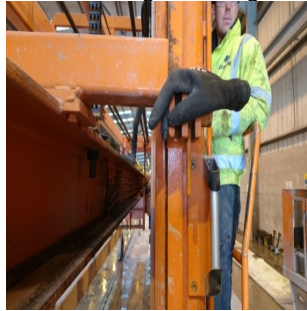
A manufacturing employee's fingers were crushed by an un-guarded trap point on a travelling stacker / lifter machine. The crush resulted in a major injury to the index and middle fingers on his left hand.

During "buddy" training on this machine, the employee to be trained was standing on the step and operating platform next to the experienced operative while observing. This secondary position allowed his hand to reach and rest on the stop block, which was unguarded from the lowering carriage. During hydraulic lowering of the main carriage, the injured person's fingers were crushed.

As part of the risk assessment, manufacturing facilities should take into account and ensure that they include any hazards created when more than one operative will access or come into contact with a machine simultaneously, e.g., training or maintenance purposes.

Guards to be installed before use and agreed with the machine manufacturer.
