LOCATION:	Concrete products plant	ARTICLE YEAR	2018
ACTIVITY:	Manual handling and storage	COMPANY:	Breedon Roof Tiles Ltd
SUB ACTIVITY:	Aggregates	COMPANY LOCATION:	Lagen Tile
BEST PRACTICE No:	BP2021	COMPANY TEL:	0000
COUNTRY OF ORIGIN:

**Elimination of manual handling & pinch point injuries**

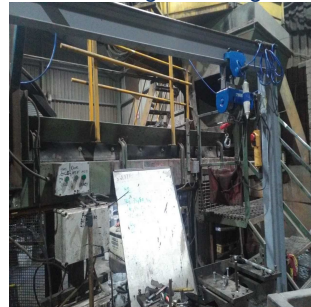
To eliminate both hazards an overhead beam together with a trolley fitted with an electrical winch were installed. The weight of the slipper was fully supported by the winch whilst it was moved into position. A handle was attached to the slipper, to aid finer positioning during installation, and lifting eyes to simplify connecting to the winch cable. A storage table for the slippers with lockable wheels was also introduced, the table can be moved along in line with the with beam.
