BEST PRACTICE

Quarry
Production and Processing
Aggregate processing
BP2081

Removal of bucket belt issues and confined space working

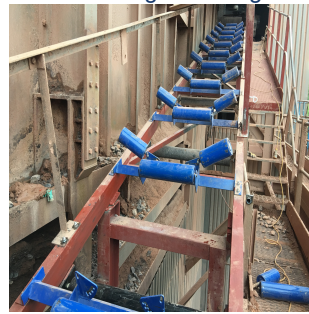
Aggregate Industries' Westleigh Quarry had a problem with a bucket belt and straight conveyor that was lifting when empty due to a change in gradient and snagging on the tail drum.

Wheels used on conveyor
