BEST PRACTICE

LOCATION:	Readymix or mortar plant	ARTICLE YEAR:	2026
ACTIVITY:	Maintenance & Housekeeping	COMPANY:	Tarmac
SUB ACTIVITY:	Mixers	COMPANY LOCATION:	RMX Southwest
BEST PRACTICE No:	BP2262	COMPANY TEL:	0000
COUNTRY OF ORIGIN:

Topic 2 - Fatal 3 - Drop down discharge chute

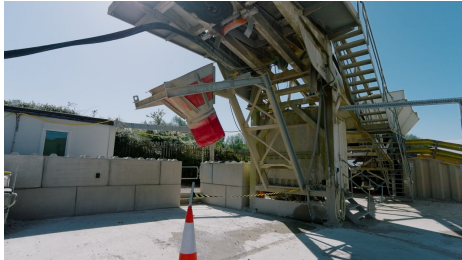
At one of Tarmac's mobile RMX concrete batching plants, an employee became trapped by a falling lump of hardened concrete whilst cleaning the inside of the chute. The operator dislodged a large lump of concrete which slid down the cone towards him and trapped his right arm. The lump obstructed his exit route and he became trapped. The emergency services were called and were able to help free him, fortunately he only received scratches to his chest, but his injuries could have been far worse.

Tarmac recognised that a redesign of the chute was required to eliminate the possibility of this type of accident occurring again at this, or other similar mobile batching plants.
