BEST PRACTICE

LOCATION: Quarry
ACTIVITY: Manual handling and storage
SUB ACTIVITY: N/A
BEST PRACTICE No: BP309
COUNTRY OF ORIGIN: United Kingdom

ARTICLE YEAR: 2006
COMPANY: Ennstone
COMPANY LOCATION: Burford Quarry, Oxfordshire
COMPANY TEL: 01993 842391

New hopper to remove semi-dry concrete sticking

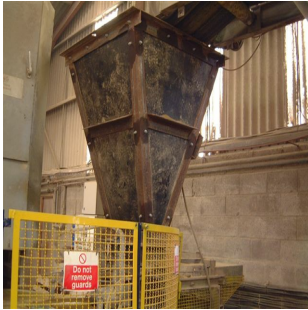
rubber hopper close-up

The machine operator led to the development of a hopper lined with thick conveyor rubber. This has produced a hopper that rarely suffers from build-up of semi-dry concrete. This solution has also removed the need for heavy manual intervention as, on the infrequent occasions that the material does build up, a simple tap on the side removes it.

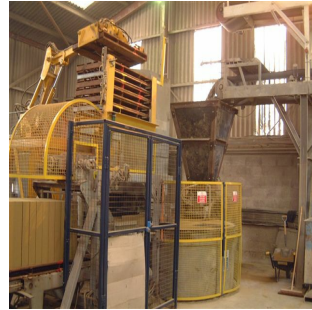
rubber hopper at a distance
