BEST PRACTICE

LOCATION: Quarry
ACTIVITY: Production and Processing
SUB ACTIVITY: Aggregate processing
BEST PRACTICE No: BP310
COUNTRY OF ORIGIN: United Kingdom

New hopper to remove semi-dry concrete sticking

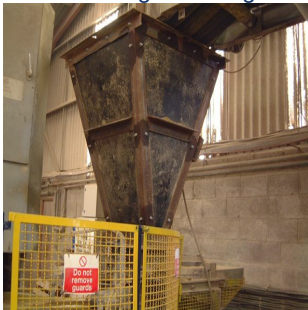
rubber hopper close-up

The machine operator led the development of a hopper lined with thick conveyor rubber. This has produced a hopper that rarely suffers from build-up of semi-dry concrete. This solution has also removed the need for heavy manual intervention as, on the infrequent occasions that the material does build up, a simple tap on the side removes it.

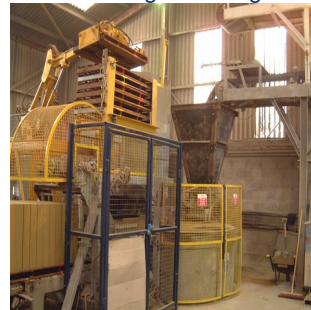
rubber hopper in the distance
