BEST PRACTICE

LOCATION: Concrete products plant ARTICLE YEAR: 2006
ACTIVITY: Maintenance & Housekeeping COMPANY: CEMEX
SUB ACTIVITY: N/A COMPANY LOCATION: Wormit concrete plant, Fife
BEST PRACTICE No: BP326 COMPANY TEL: 01382 541641
COUNTRY OF ORIGIN: United Kingdom

Paddle lock bars for the mixer

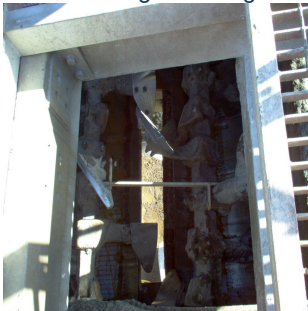
Millar Mixer

There was a risk of injury during the manual cleaning of the Millar Mixer. Whilst it was possible to stop the mixer from working, there was still the hazard of the paddles rotating manually during cleaning.

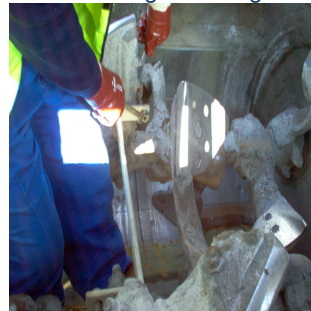
Paddle lock

The team at this site came up with a paddle lock to solve the problem. The bar was designed to fit over the paddle arms and be locked into place using bolts and tightened with the use of spanners. This meant that, in order for the paddles to become free again, a tool had to be used - they could not be set in motion by accident.
