## BEST PRACTICE

TITLE

<b>New tool to remove drive chamber insert from from mortar plant</b>	
<b>ARTICLE</b>	
<p>Description</p> <p>The removal of the dry chamber insert, which is the metal disk at the end of the chamber of a dry mortar mixing unit, took engineers around ten minutes. The task required the use of a hammer and nail to free the insert. This was very strenuous, time consuming and resulted in a near miss.</p> <p>Following this incident, a tool was developed by one of the engineers - a dry chamber insert extracting tool. The tool is simple to use and eliminates the need for any other tools. Utilising the motor of the silo, the insert can be removed in under a minute.</p> <p>Benefit</p> <p>The new system significantly reduces maintenance time and eliminates a potentially hazardous job.</p>	
<b>ARTICLE IMAGES</b>	
<p>Click image to enlarge</p>

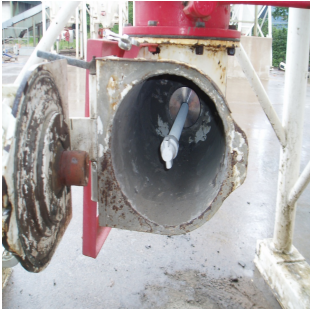
<p>New method</p>
