## INCIDENT ALERT

**LOCATION:** ON-HIGHWAY  
**ACTIVITY:** MANUAL HANDLING AND STORAGE  
**SUB ACTIVITY:** AGGREGATES

**Hydraulic Breaker Incident**

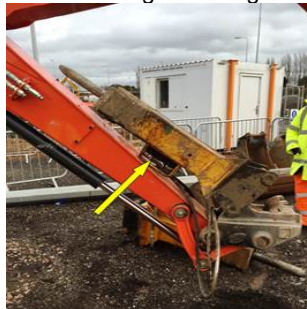
A sub contractor employee sustained a double fracture and crush injuries to his left forearm as a result of trapping his arm between a hydraulic breaker and the boom of a 360 degree excavator. The Injured Party (IP) and a colleague were assisting the excavator operator to change the ditching bucket attachment for the hydraulic breaker on the 8 tonne excavator. The two men were stood either side of the excavator boom holding the hydraulic hoses clear of the quick hitch attachment, as the operator attached the front 'bar' of the breaker to the quick hitch socket on the excavator. The breaker was then lifted to allow the 'rear bar' connection to be made. As the boom of the excavator was being manoeuvred into position, the IP put his arm across the boom and attempted to connect the breakers hydraulic hose to the connections on the boom, when the breaker fell forward trapping his arm between the breaker and the boom. • All involved in the incident failed to ensure that the machine was isolated, which resulted in the two pedestrians placing themselves in an unsafe position. • The operators' manual and the training delivered to excavator operators clearly states that the changing of attachments is the machine operators' responsibility. This was furthered confirmed during the investigation, when talking to other machine operators. • The operating procedure for engaging and releasing the mechanical quick hitch clearly states that the operator should 'keep bystanders away when engaging or releasing attachments'. • Other excavator operators have confirmed that they undertake the changing of attachments themselves as it is safer and easier. This ensures that the machine is isolated and that all stored energy in the hydraulic system is released, making the hose connection significantly easier. • The quick hitch was found to be in good working order at the time of the investigation so it must be concluded that the operator failed to connect the quick hitch to the attachment correctly. • A near hit occurred earlier in the shift with the same team of men. The breaker dropped to the floor from the bucket of a 6 tonne excavator, due to the quick hitch not being correctly attached. This was not reported at the time and only came to light during the investigation process. • The sub contractors Safe System of Work / Safe Operating Procedures (SSoW / SOPs) did not detail the process for the changing of attachments using the quick hitch and attaching the hydraulic hoses.

**Trap Point**

Company site managers/supervisors must: • Ensure that the contents of this alert is discussed with all site personnel and supply chain partners. • Ensure that operators of plant fitted with quick hitch devices are reminded of their duties in relation to changing over attachments, ensuring that the machine is isolated and all stored energy released before commencing the operation. • Remind everyone of the importance of reporting near hits, as this may prevent a more serious incident occurring at a later date. • Ensure that incidents are appropriately investigated and lessons disseminated. • Ensure that the Company 5m plant and vehicle exclusion safety zones are reiterated to everyone on site. • Review SSoW / SOPs to ensure that the use of the quick hitch is clear and prohibits anyone from placing themselves in the exclusion safety zones. The Operations Manager must ensure that this incident is highlighted and discussed with supply chain partners, and that they ensure their SSoW/SOPs adequately address this type of activity. (Safequarry Editors Note: A Best Practice Guide on the Safe Use of Quick Hitches on Excavators can be downloaded free of charge from the Construction Plant-hire Association website <http://www.cpa.uk.net/sfsgpublications/#QuickHitches>)
