Safety Alert

RCE/09/010
16 Dec 2009

Serious Accident Involving a Road Planing Machine

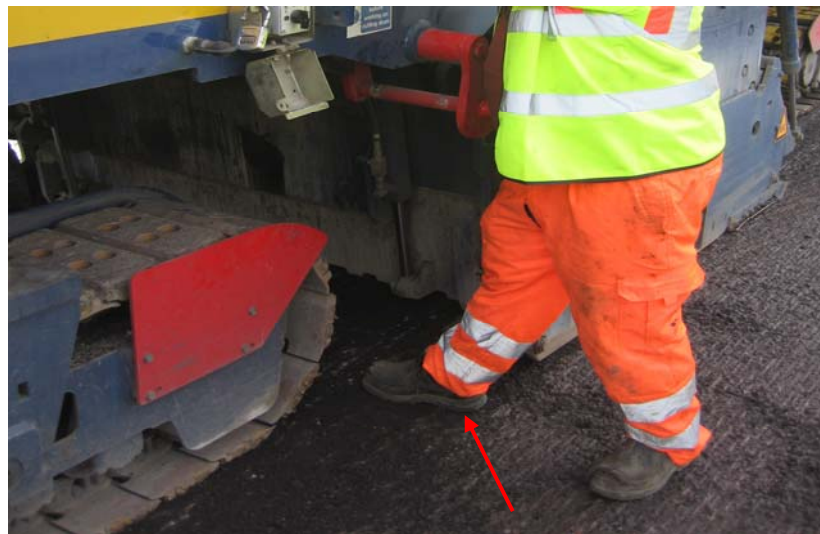
During this activity, the screwman used his foot to scrape excess planings from the road to check the level of the surface. In doing so, he placed his foot between the rear of the cutting drum and the front of the machine's tracks. The machine was travelling at a quick walking pace and the tracks ran over his foot and crushed his toes. The machine operator was unaware of the position of the screwman.

Photo depicting where not to place feet

- Screwmen, when monitoring surface levels, are to position themselves at the rear of the planer with the machine travelling away from them.
- Planer operators and supervisors are to be aware of the screwman's position when checking levels.
- Feet, or any other body part, must not, under any circumstances, be placed in front of the tracks of a planer or similar machines, even if at rest.
