# Sweeper Reversing Incident

LOCATION: ON-HIGHWAY  
ACTIVITY: PRODUCTION AND PROCESSING  
SUB ACTIVITY: ASPHALT & COATED STONE

ALERT STATUS: Normal  
DATE ISSUED: 29/05/2015 14:21:12  
INCIDENT No: 01414

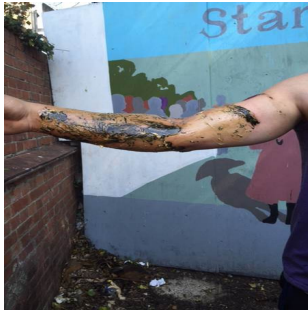
Operative A collided with Operative B and both fell to the ground. Operative B suffered a fractured wrist as a result of the impact with the ground. Bitumen from the can was also spilled resulting in burns to Operative B.

Bitumen went inside gauntlets

1. A full investigation is being carried out, that includes 3rd party companies and internal staff.
2. Witness statements shall be taken and recorded from all relevant staff.
3. Use of RHINOweld Gauntlets (Full Sleeved) and Full Face Visor to be re-enforced by Managers/Supervisors.
4. Managers/Supervisors to re-visit all gangs and ensure all are appropriately inducted.
5. A review of working practices shall be undertaken and potentially recommendations may be advised.
