Failure to isolate results in electrical burns

ALERT STATUS: Normal
DATE ISSUED: 01/10/2015 21:30:38
INCIDENT No: 01419

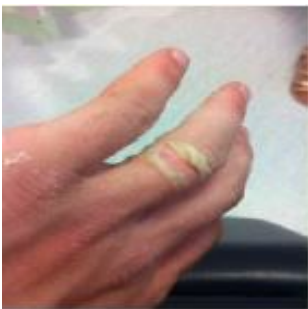
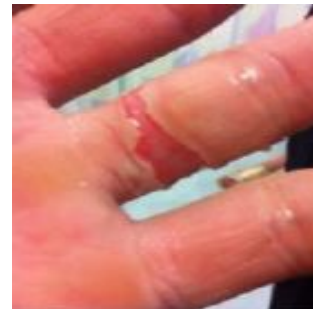
A contractor was called to a site after a fault was reported with a hired generator. Whilst tightening the bolts on the lift pump using a socket wrench the contractors' ring came into contact with the exposed positive terminal of the starter motor. Despite wearing latex gloves, the ring became instantly heated causing the contractor to sustain a burn to the finger.

On examination it was found that a number of terminals of the starter motor were exposed due to poorly fitting rubber insulating covers. The contractor had commenced work on the generator without isolating or disconnecting the battery. This was not in accordance with the contractors risk assessment and method statements, or the guidance provided on the door of the container housing the generator. In a statement given by the contractor, he stated that he "...didn't feel that there would be any danger from a 12 Volt battery".

- Are Contractors registered on the MPA National Contractor Database?
- Have they completed the industry Contractor Safety Passport?
- Ensure Contractors coming onto your site are competent to do the work they have been employed to do;
- Contractors must receive a site induction;
- Risk assessment and Method statements should be reviewed with contractors prior to commencing work.

- Risk assessments and Method statements should be fit for purpose, specific to the work planned and understood by those undertaking the task;
- Contractors should not be left to their own devices once on site. Regular supervision visits are required to ensure they are following their own safe systems of work and site rules.
- Once work is completed ensure any plant is handed back in a safe condition and obtain feedback along with discussion on any improvements to Health and Safety, required for future work.
- When carrying out any electrical work isolate and test before you touch!
- Remove; metal bracelets, watches and rings and wear appropriate hand protection when handling batteries.
