Train Derailment

LOCATION: RAILHEAD
ACTIVITY: TRANSPORT & LOGISTICS / DELIVERY
SUB ACTIVITY: RAIL

ALERT STATUS: Normal
DATE ISSUED: 02/05/2017 09:58:22
INCIDENT No: 01450

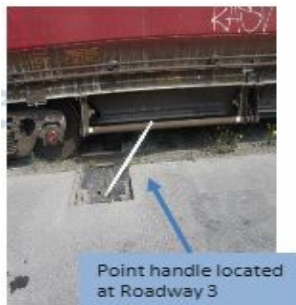
Two employees, carrying out a safety tour, entered a rail loading area and approached the location where the lever that operates the railway points is positioned. There was a roadstone train parked on the track, awaiting permission to leave the site. The employees spotted the point's lever and thought that the area around the lever could be a trip hazard. At this moment one of them moved the lever, however they were unsure if their actions affected the points on the track, so they decided to move the lever again, whereupon the points did move, changing the track from one line to another. The employees tried to seek assistance, however at that moment the train pulled away, causing a number of wagons to derail from the track. The employees were on a planned health and safety tour to identify hazards across the site for discussion in the following health and safety committee meeting - Neither of the employees had any rail safety training and were not authorised to operate the lever. - All track inspections had been completed monthly, there is no evidence to show the points were faulty.

Point handle located at Roadway 3

HOW COULD THIS INCIDENT HAVE BEEN AVOIDED? - Restrict access to sidings to authorised personnel...only trained / guided employees to be allowed in loading areas. - Increased signage at point locations, identifying no unauthorised usage. - Shield point levers to deter unauthorised access / use. - Train all employees in basic rail safety, including prohibited activities. KEY REVIEW POINTS: - ASK YOURSELF are you authorised / safe to enter restricted areas of a factory / yard? Seek authorisation to enter unfamiliar areas and, where required, ensure you are accompanied by an authorised person. -THINK before you operate plant or equipment, are you trained and authorised? - Ensure your ACTIONS are not going to affect the Health and Safety of others. - If in doubt always SEEK ASSISTANCE from trained personnel. - Are personnel aware of all HAZARDS on site? - Always Look After Yourself and Each Other... please STEP IN if you see anyone acting unsafely.
